# Lessons Learned From ASHRAE HQ Renovation

BY MICHAEL R. VAUGHN, P.E., MEMBER ASHRAE

The building is unique in that it contains three mechanical systems for heating, cooling and ventilation:

1. Dedicated outdoor air system (DOAS) for first and second floor ventilation;
2. Variable refrigerant flow (VRF) system with heat recovery for first floor heating and cooling; and
3. Ground source heat pump (GSHP) system for second floor heating and cooling.

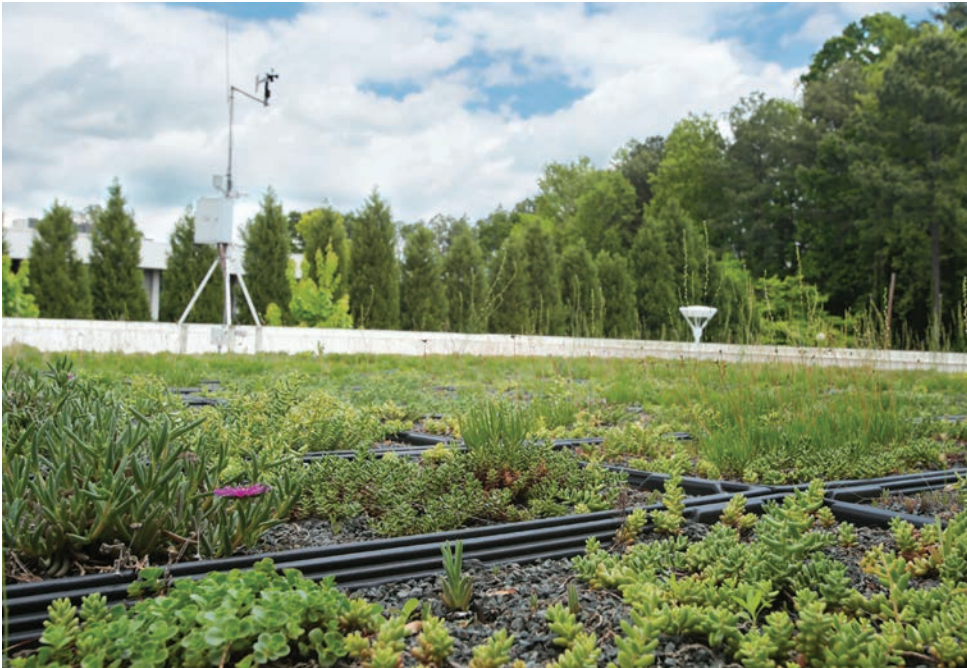
The green roof of the Learning Center consists of three types of sedum and one ice plant that each bloom multiple times per year. The weather station is connected to the BAS and measures min./max. dry bulb air temp, RH, dew point, solar radiation, hours of sun, net radiation, barometric pressure, min./max. wind speed, wind direction, gusts, gust directions, and CO<sub>2</sub>.

**Green Roof.** The green roof consists of three types of sedum and one ice plant that each bloom multiple times per year. The green roof is not supposed to require irrigation once fully established, and it helps to reduce site runoff, heat gain through the roof area, and also helps to insulate meeting space from outside noise sources.

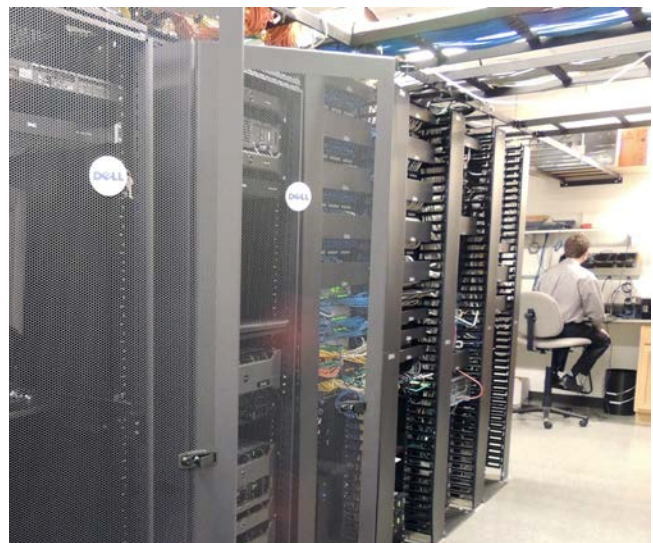
Virtualized servers reduced server footprint by 80%, emptying one rack entirely.

In 2009, we were pleasantly surprised that our plug loads and computer room electrical loads dropped 20% to 30% after we switched out leased desktop computers for a thin-client system, and replaced server racks for blade-type servers. Also, after these changes, the two ceiling-mounted VRF units that cool the computer room were each fully able to keep up with the load in the room on even the hottest summer days.

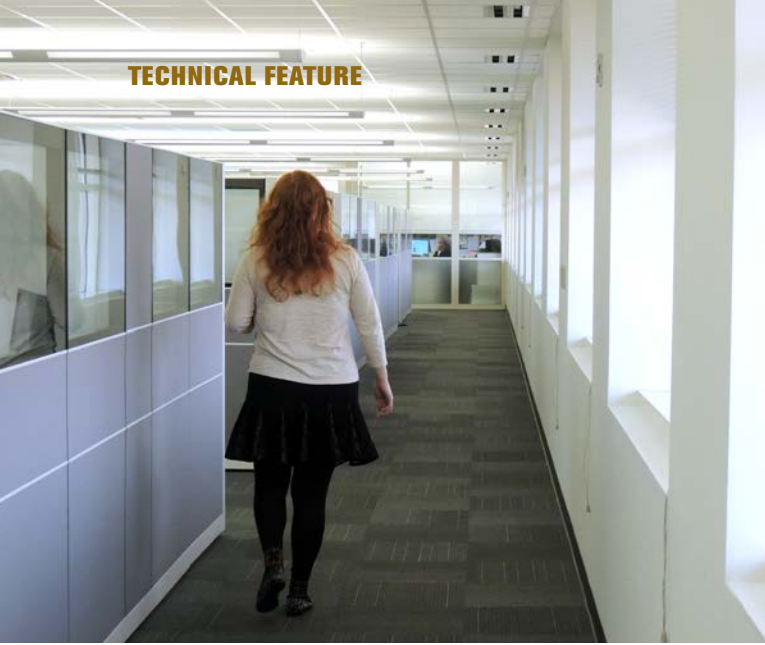
(Left) Slot diffusers run along the perimeter ceiling. (Right) Air quality satisfaction increased from 26% in 2005 to 77% in 2010 and 70% in 2013.

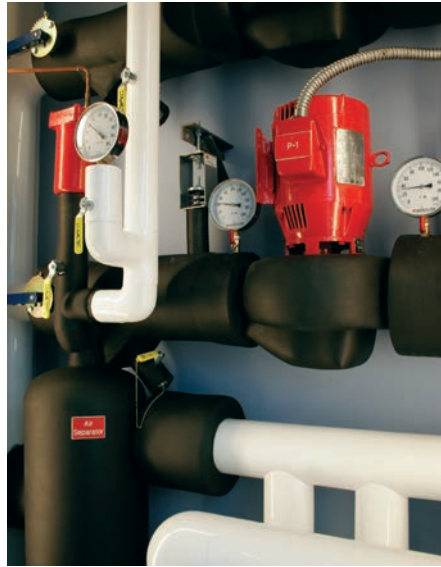
The differential pressure setpoint for the geothermal closed loop was initially set at 20 psi via hand calculations. Through trial and error, the final setpoint was lowered to 15 psi.

The differential pressure setpoint for the closed loop was initially set at 20 psi (138 kPa) via hand calculations. Through trial and error, we found that we were able to reduce this setting to as low as 12 psi (83 kPa) before the heat pump located furthest from the pump (north stairwell console unit) dropped out, which allows pump energy consumption in the system to be reduced. The final setting was 15 psi (103 kPa) to ensure we received adequate flow to all heat pumps, which is consistent with the design engineer's original estimate of a 15 psi to 20 psi (103 kPa to 138 kPa) setpoint range.

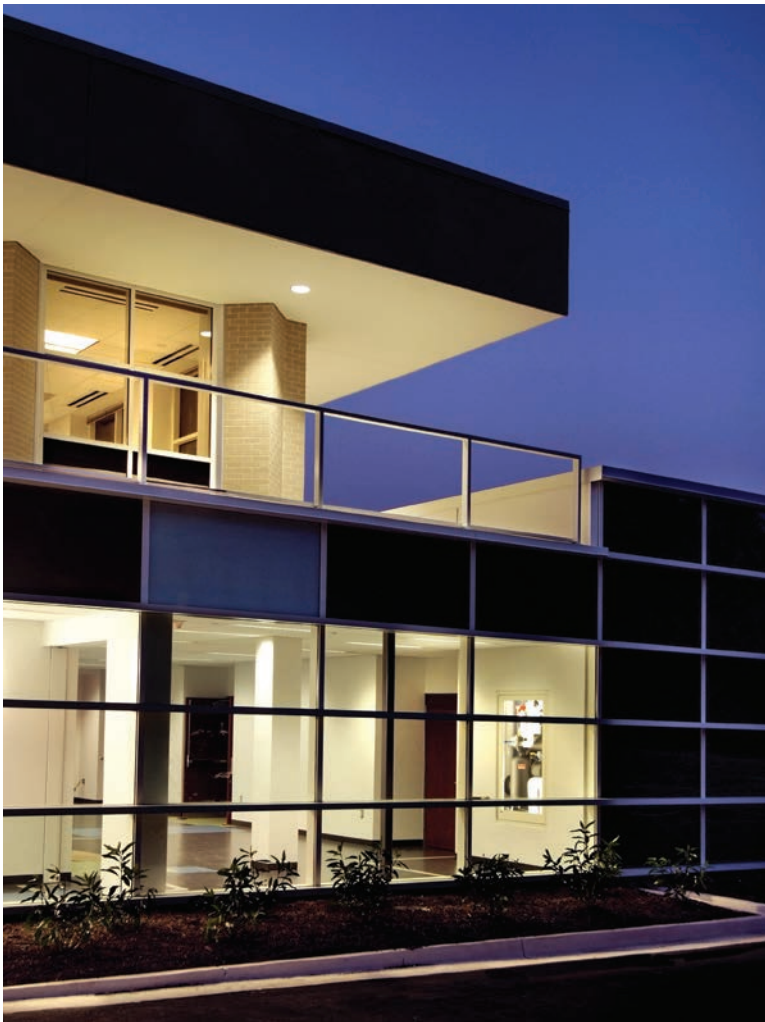
Photocells, occupancy sensors, and occupancy schedule are used to control lighting use. A change-out to LED lights in some locations is being considered.

Interior lighting power density is 19% lower than ASHRAE/IESNA Standard 90.1-2004. Photocells, occupancy sensors, and occupancy schedule are used to control lighting use. A change-out to LED lights in some locations also is being considered as an additional energy savings improvement.

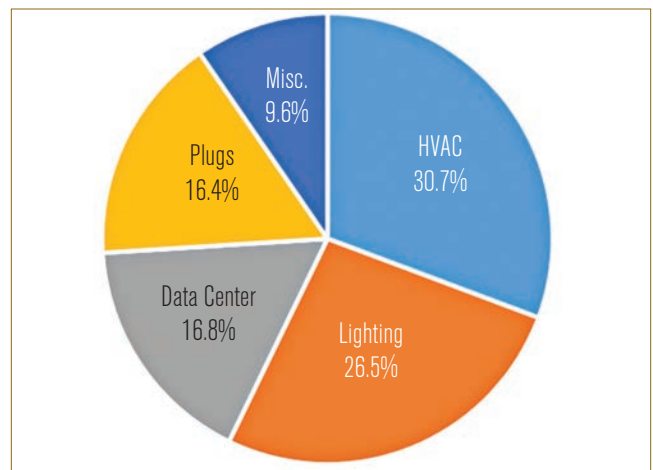
Electrical energy end use for ASHRAE headquarters.

Submetered Panels: first floor lighting; first floor plug loads; first floor mechanical; second floor lighting; second floor plug loads; second floor mechanical; DOAS; PV array; computer room (server load + cooling load); outdoor lighting; and water heating.
